## إعادة تأهيل ابار النفط والغاز

Oil wells in the fields were subject to acts of sabotage through the bombing and bombing of the well heads and the oil flowed from some of them freely.

The following works were carried out by the technical team of our company:

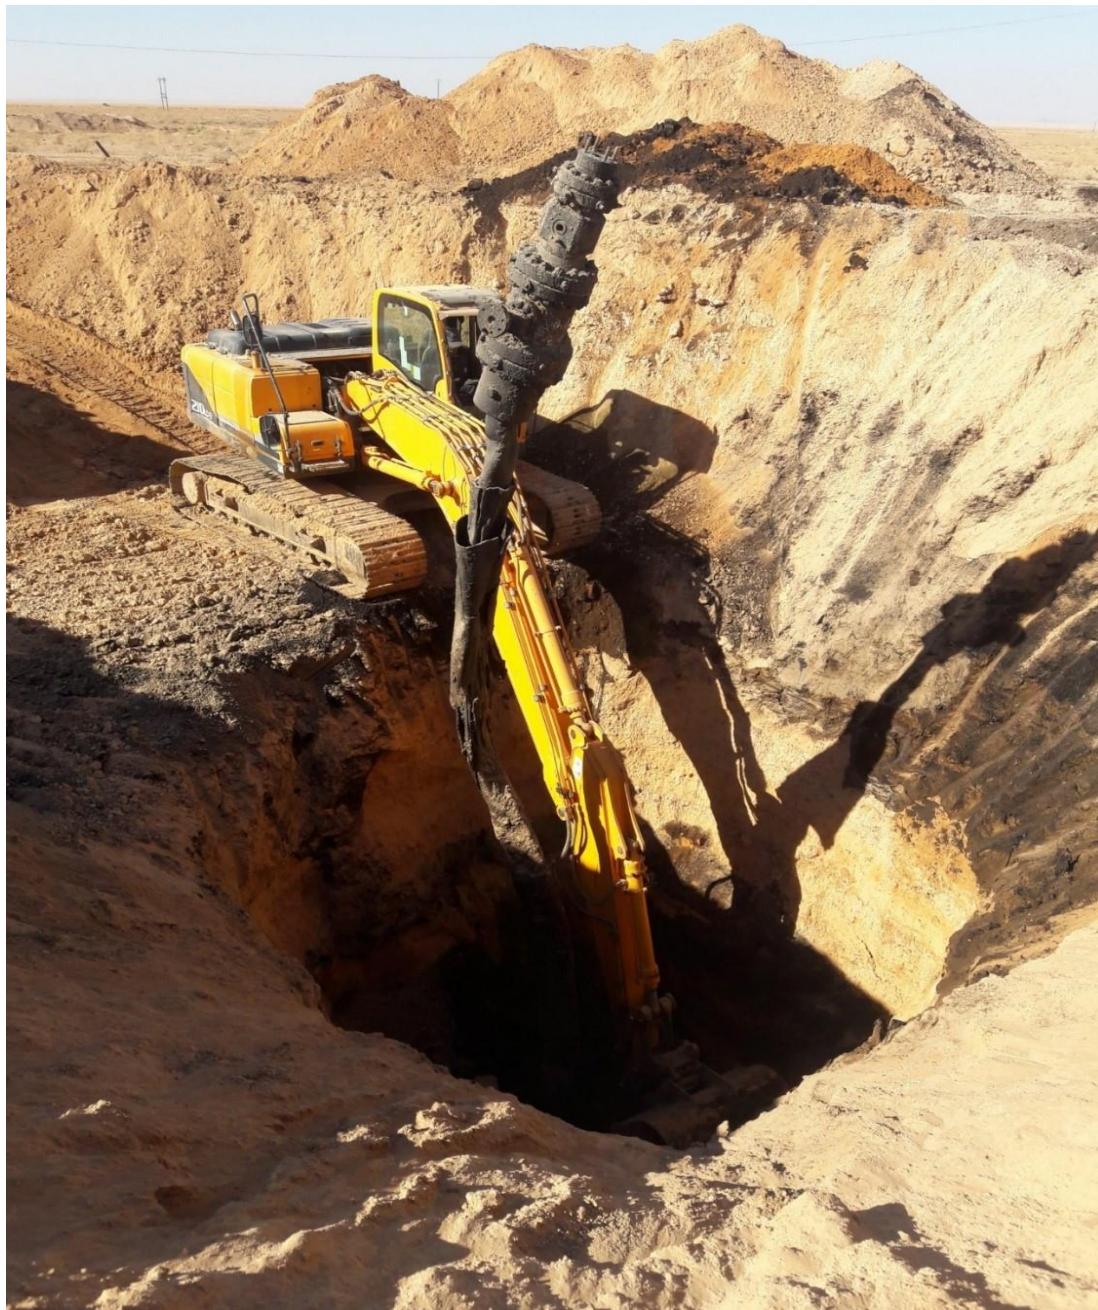
Detecting damaged casing from an oil well to be replaced

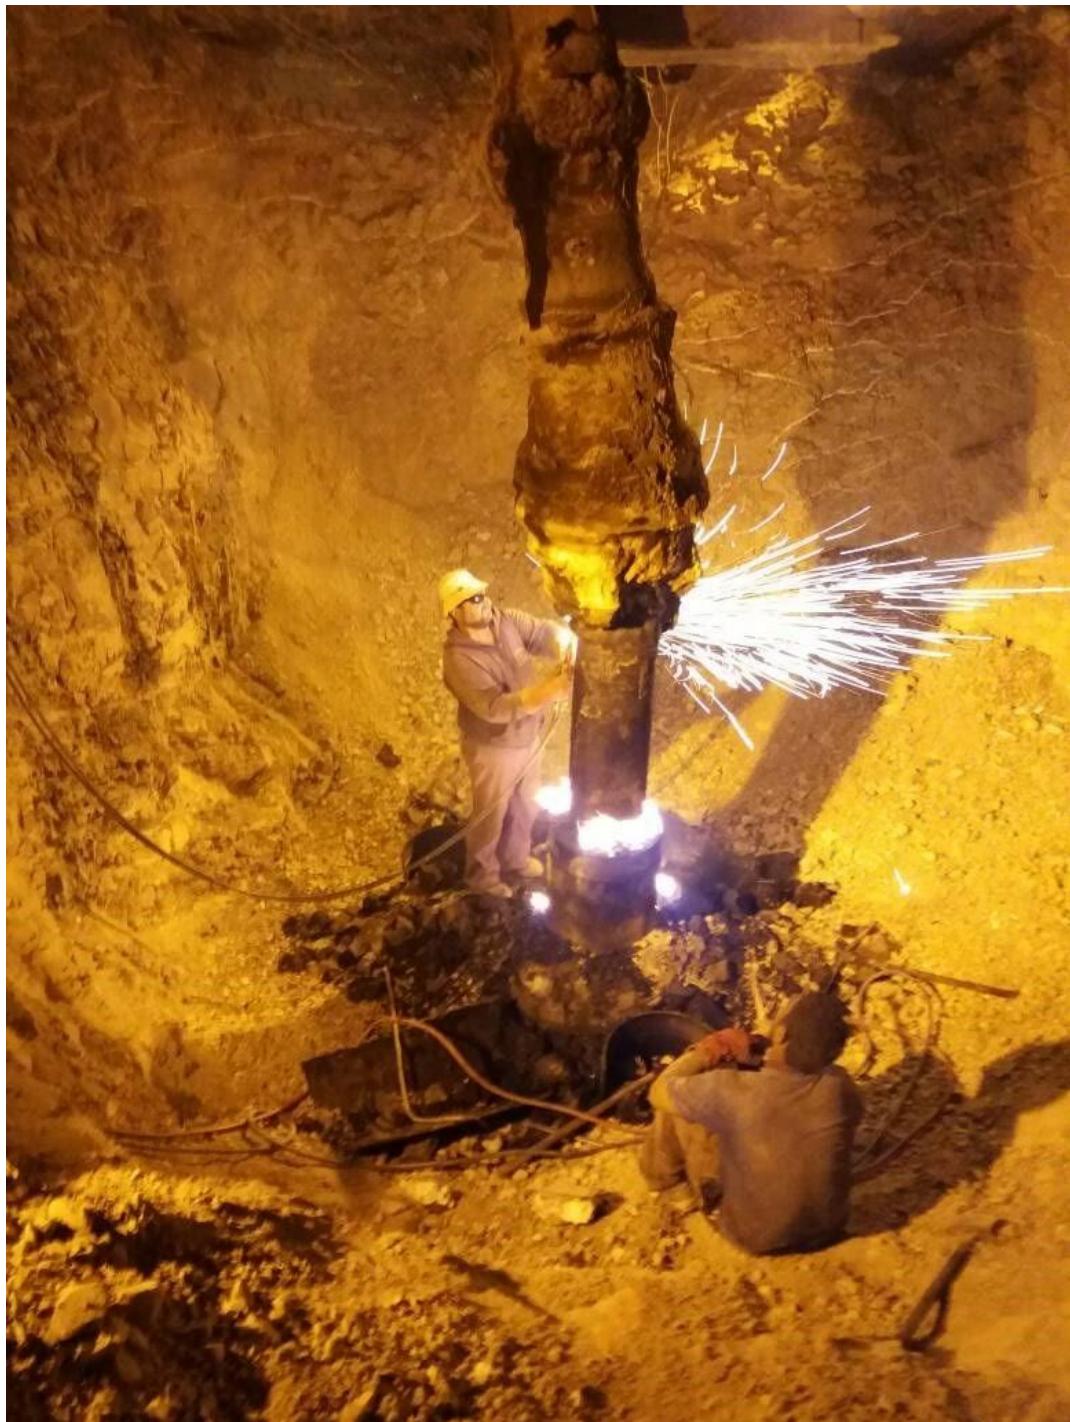
Cut the damaged parts of the casing pipes to be replaced with new.

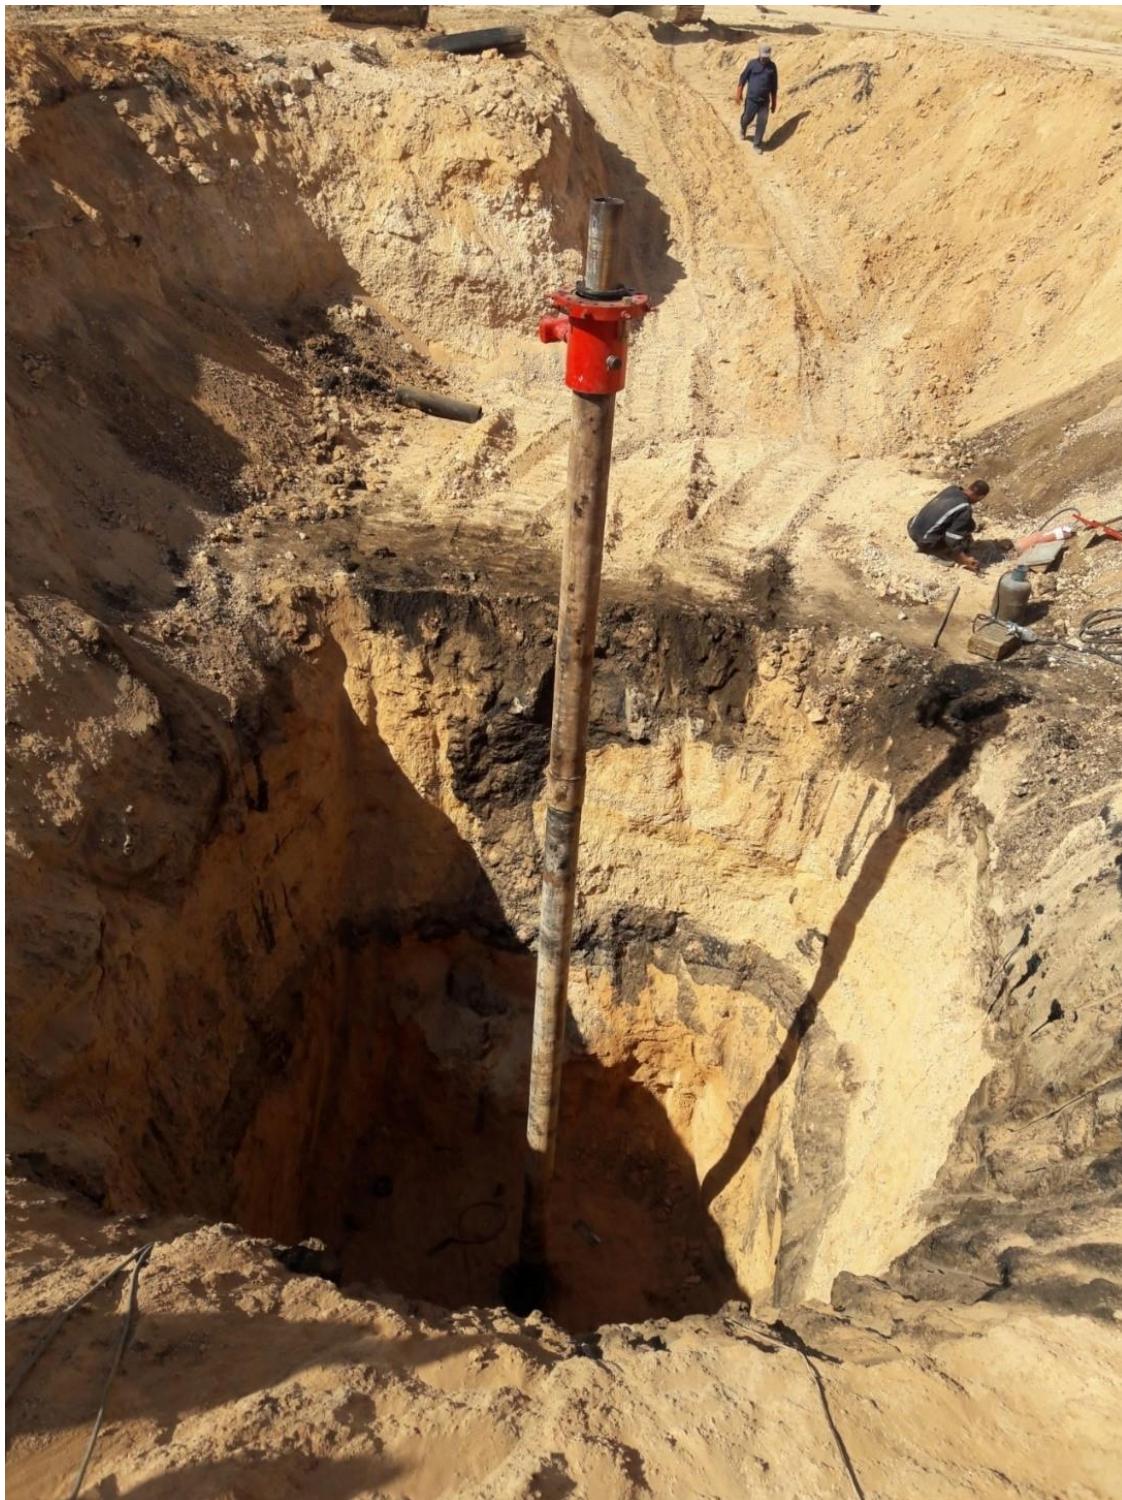
the oil well after replacing the damaged casing with new ones

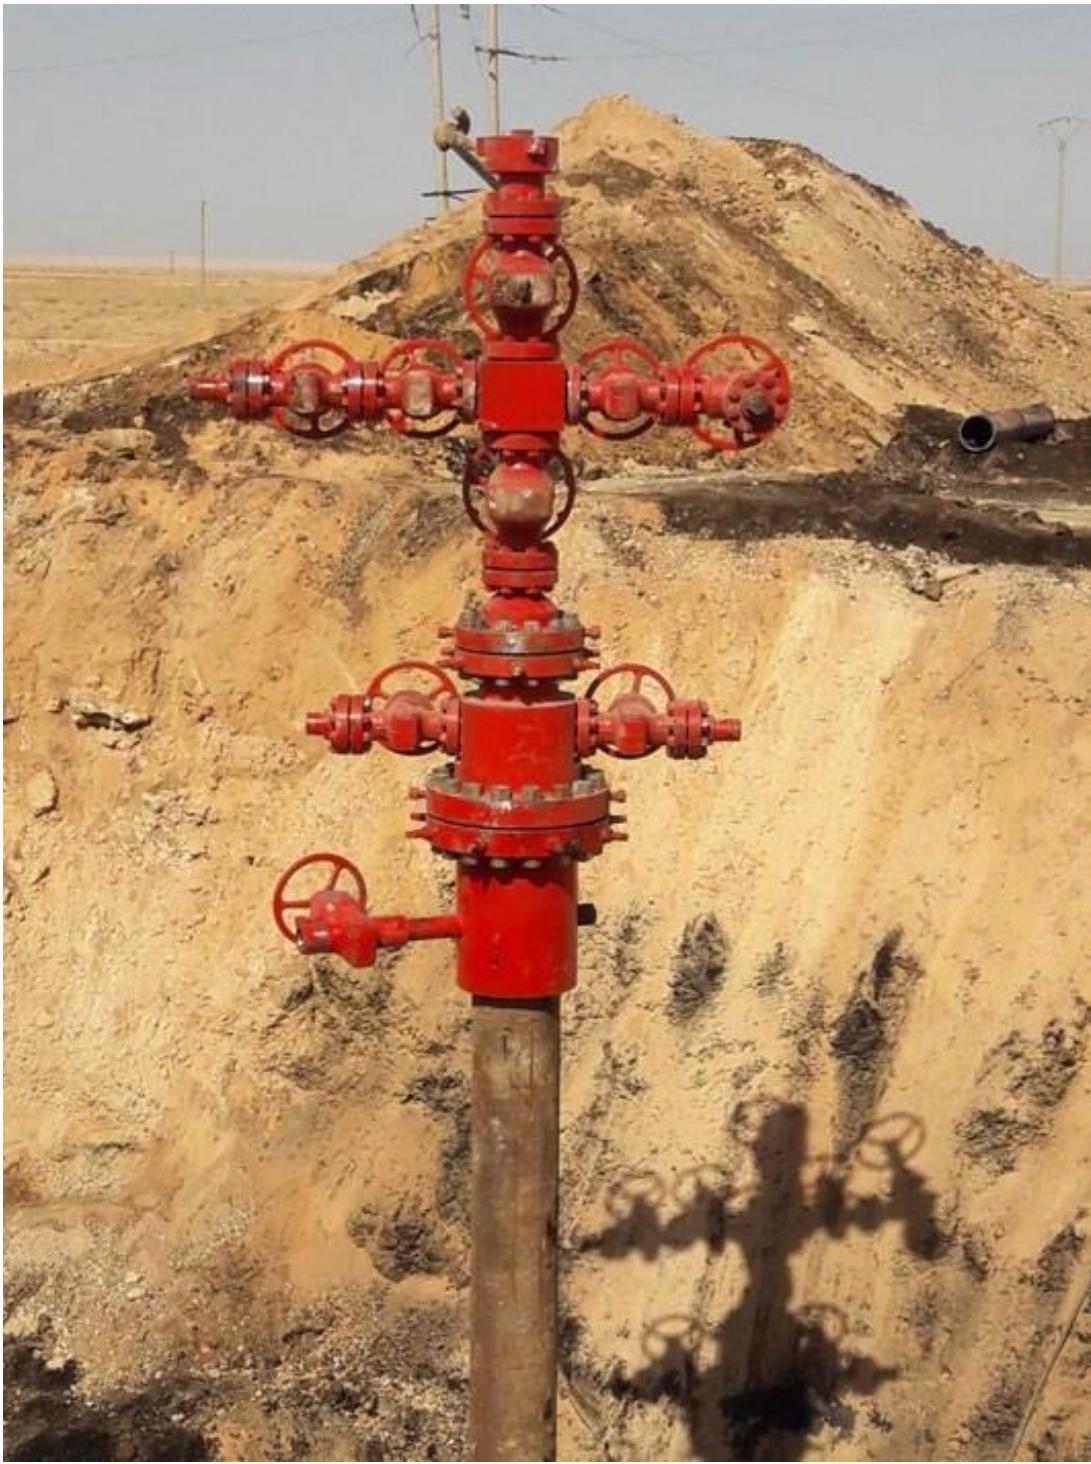
Installation of the well head, Christmas tree and preparation for cementing
